Re: Monthly Report Summary #15 for the South Orange County Reliability Enhancement (SOCRE) Project

CPUC Site Inspection Reports
January 4, 10, 23, and 29, 2019

South Orange County Reliability Enhancement Project CPUC Site Inspection Form

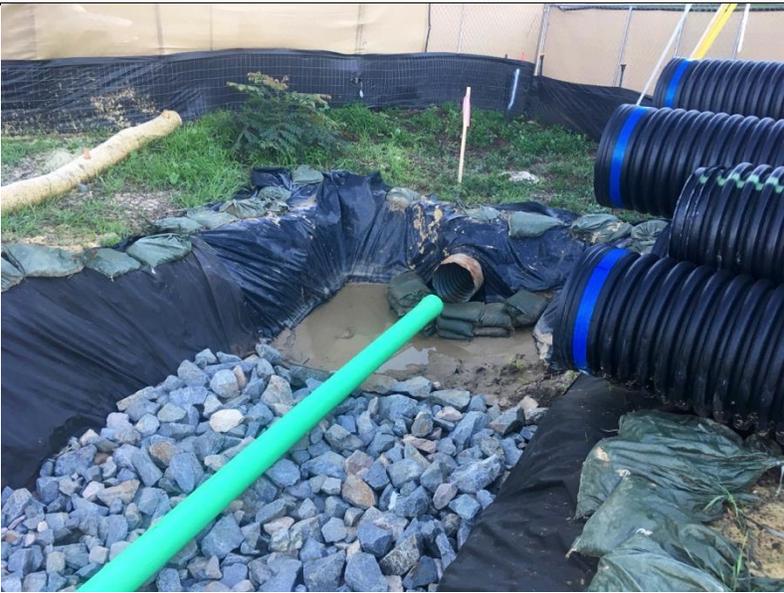
Photo 1 – Small catch basin in the southwestern corner of the San Juan Capistrano Substation site. Photo facing southwest.

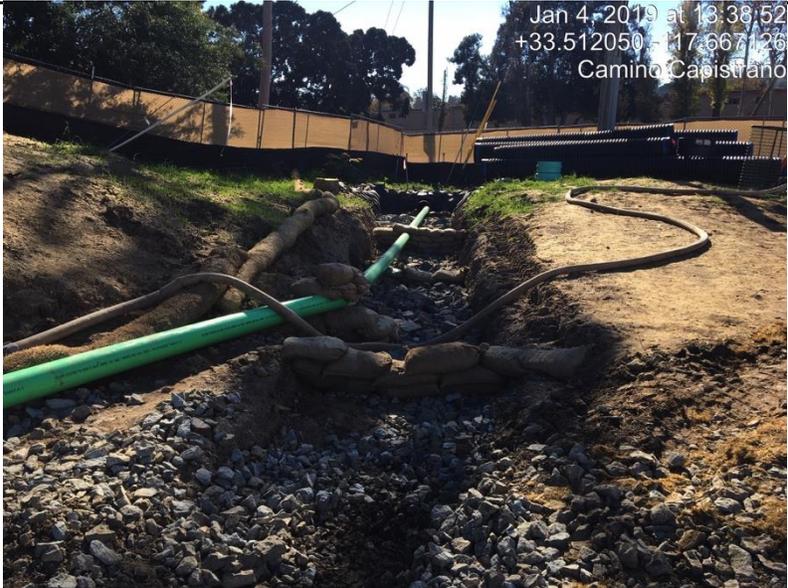
Photo 11 – Photo sent by the SDG&E Environmental Coordinator showing upgrades to the catch basin.

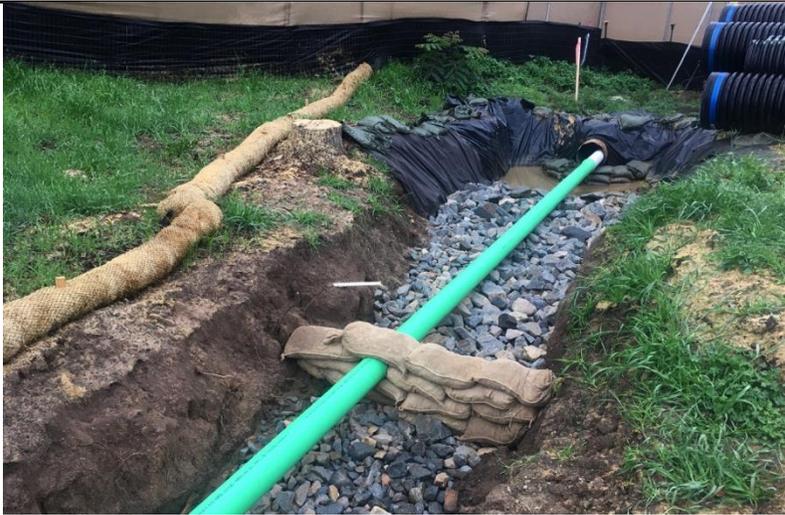
Photo 1 – Upgraded BMPs in the small catch basin. Photo facing southwest.

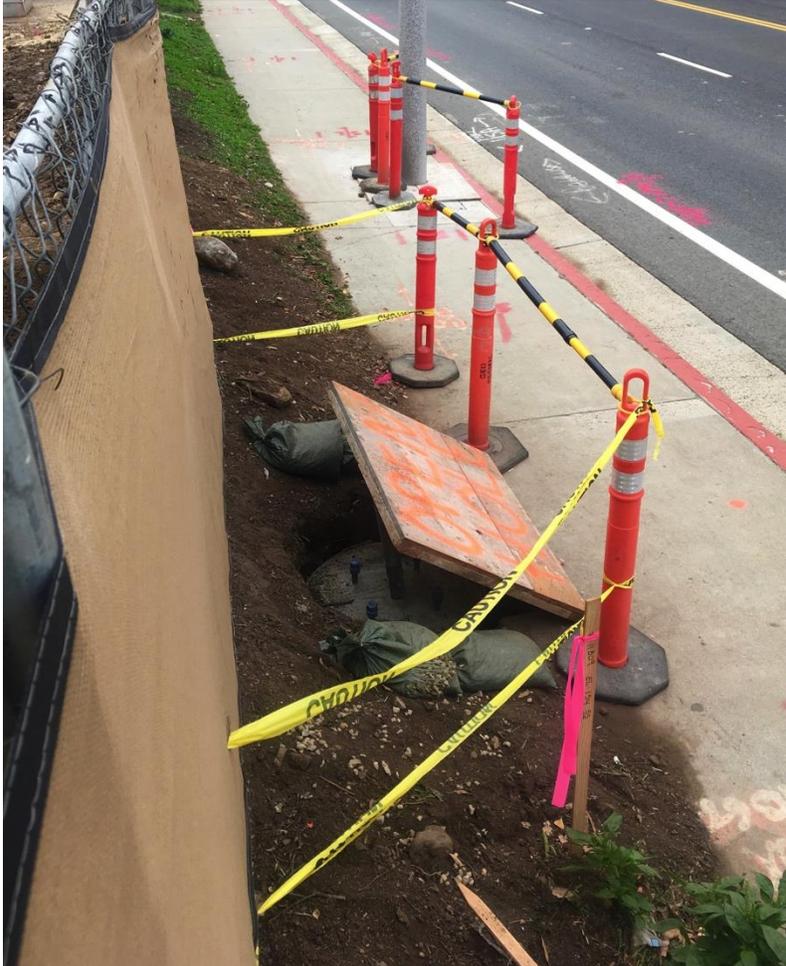
The foundation has been poured for the relocation of the streetlight within the sidewalk outside of the San Juan Capistrano Substation site (Photo 14).

Photo 14 – New street light foundation for the streetlight relocation from Camino Capistrano. Photo facing south.

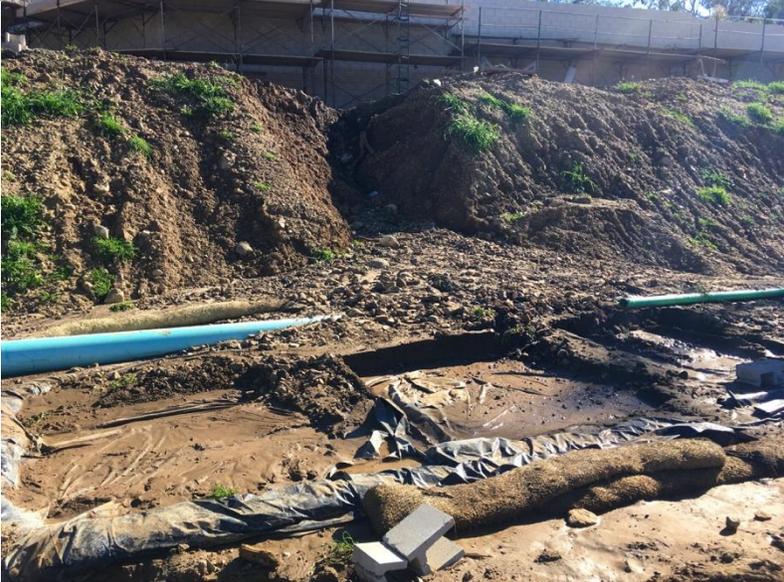
- (1) Collapse of a fill slope below the southern boundary wall (Photo 4). The cause needs to be evaluated and cleanup work needs to be completed in this area.
- (2) A piece of equipment broke the pipe that transports rainwater runoff from the San Juan Capistrano Substation site to the outfall culvert (Photo 6). The extra water from this pipe filled the catch basin below the San Juan Capistrano Substation site, causing it to overflow (Photo 5). The pipe has been fixed.

Photo 4 – Fill slope below the southern boundary wall that collapsed during a rain event. Photo facing south.

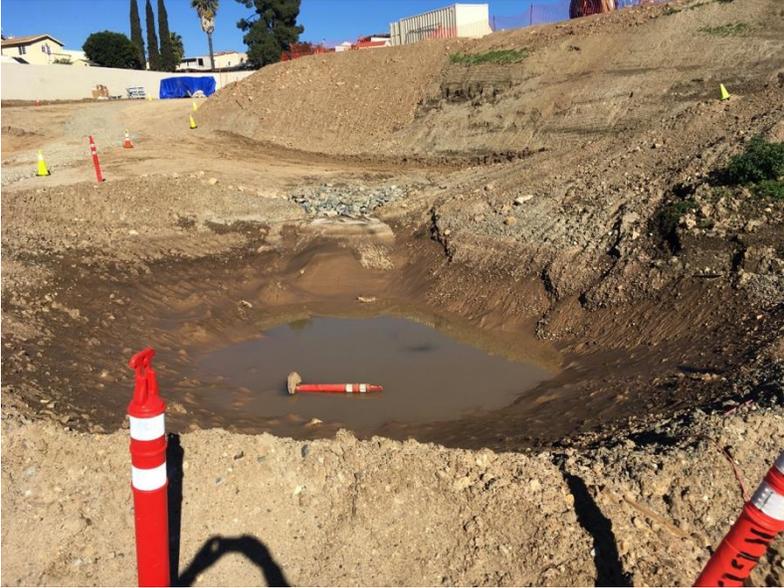
Photo 5 – Expanded rainwater catch basin within the San Juan Capistrano Substation site. Photo facing northeast.
1/23/19	San Juan Capistrano Substation

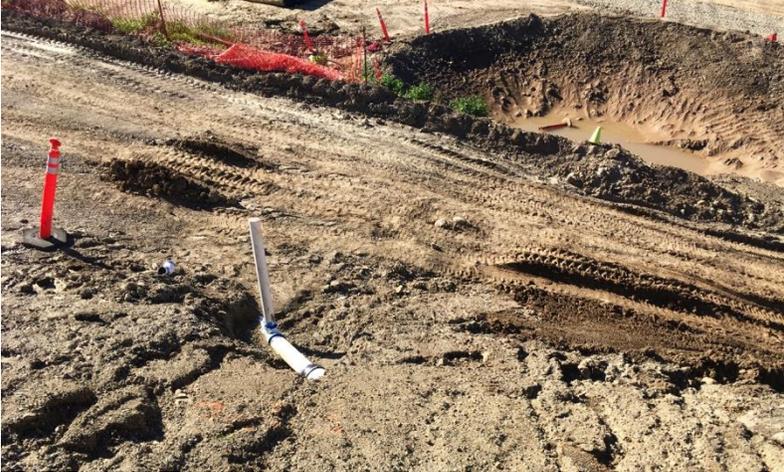
Photo 6 – Broken pipe above the catch basin. The pipe has been fixed.
1/23/19	San Juan Capistrano Substation

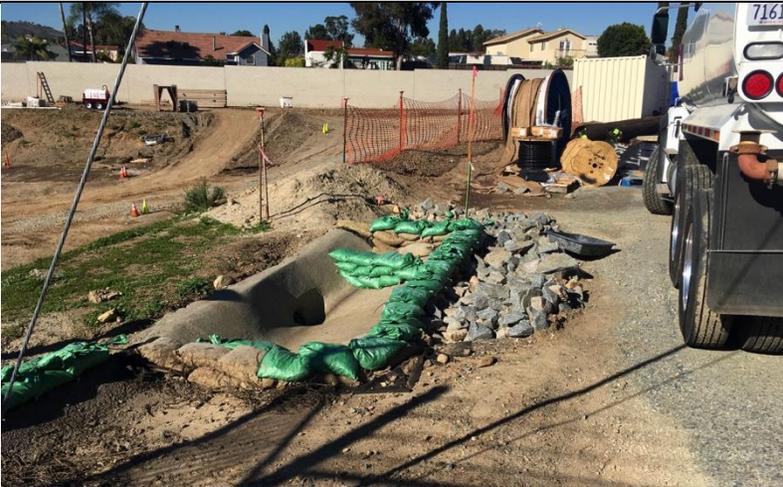
Photo 8 – BMPs added to the San Juan Capistrano Substation site drain inlet. Photo facing north.
1/23/19	San Juan Capistrano Substation

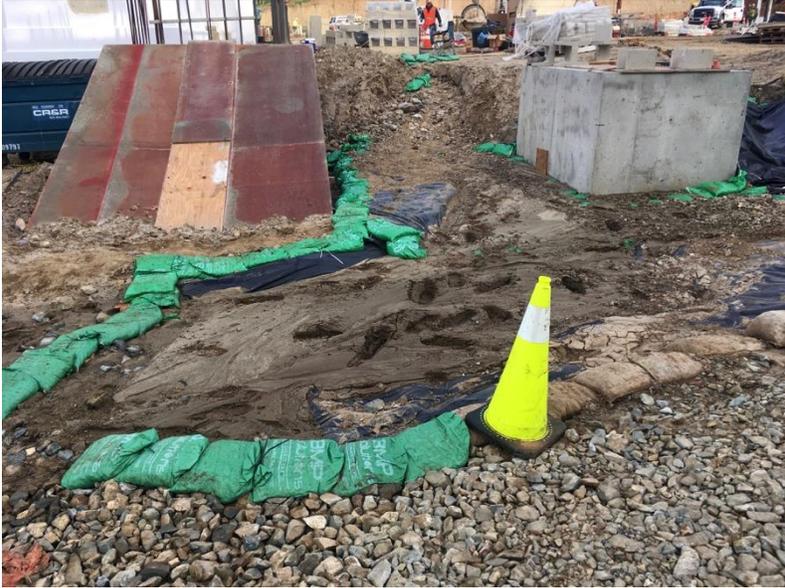
Photo 1 – BMPs requiring upgrades.
1/29/19	San Juan Capistrano Substation

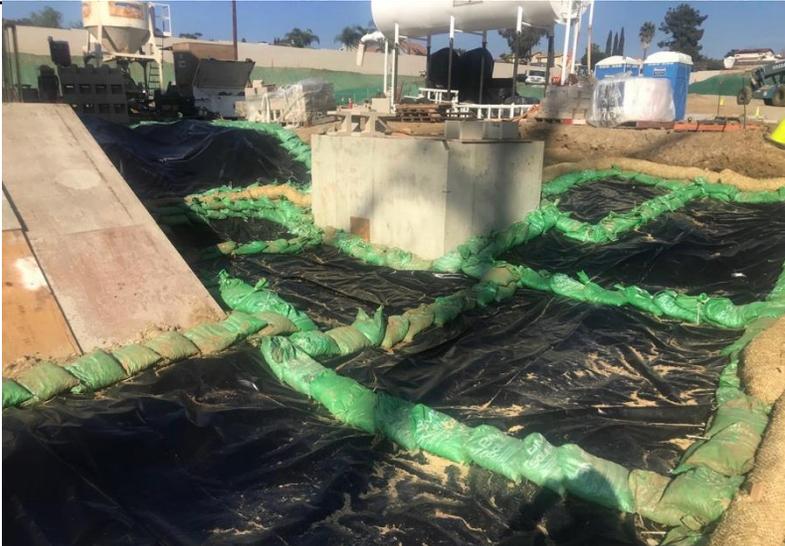
Photo 2 – Photo from SDG&E Lead Environmental Inspector showing upgraded BMPs at the area shown in photo 1. Photo facing north.
1/29/19	San Juan Capistrano Substation

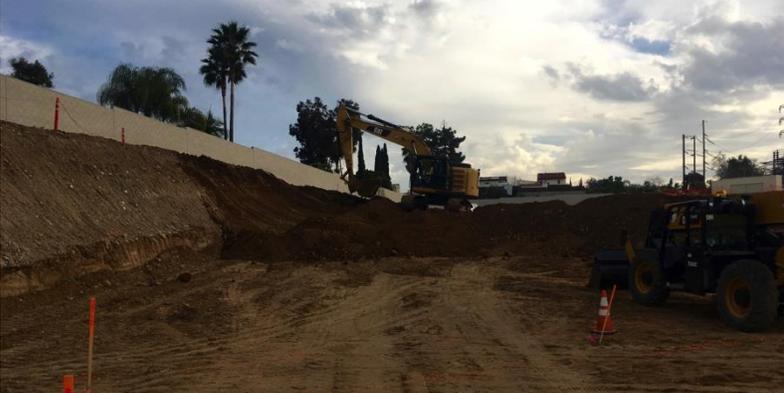
Photo 6 – Excavator cutting back the slope below the northern boundary wall. Photo facing northeast.

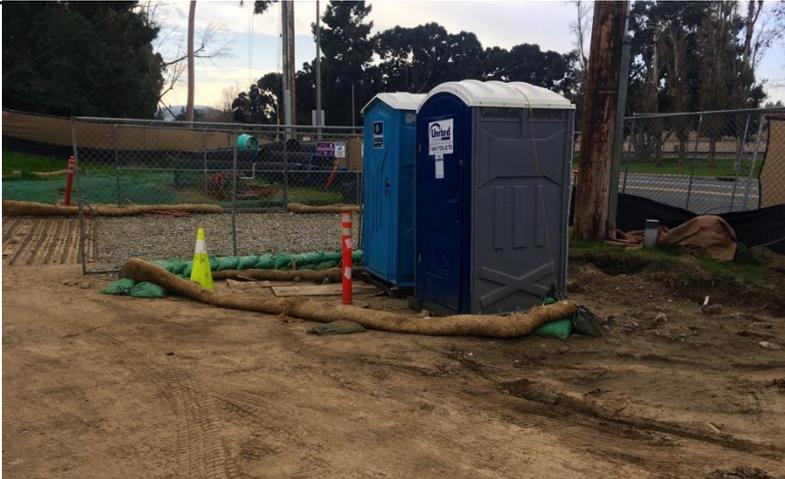
A photograph showing two blue and grey port-a-potties situated on a dirt area. The potties are surrounded by orange safety cones and a chain-link fence. In the background, there are trees and a building.	Photo 14 – Port-a-potties to be relocated. Photo facing south.
